Manhole Inspection Summary

Manhole # S31EE2005MH

Location Address: **36 MELROSE AVE**

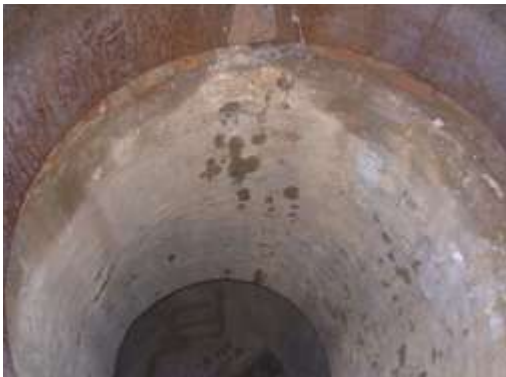
Defect

Condition: ☐ Sound ☐ Cracked ☐ Root Intrusion ☐ Loose Brick ☒ **Deteriorated**

Infiltration: ☐ None ☒ **Joint** ☐ Cracks ☒ **Mortar** ☐ Roots ☐ Wall

Adjustment deterioration and infiltration.

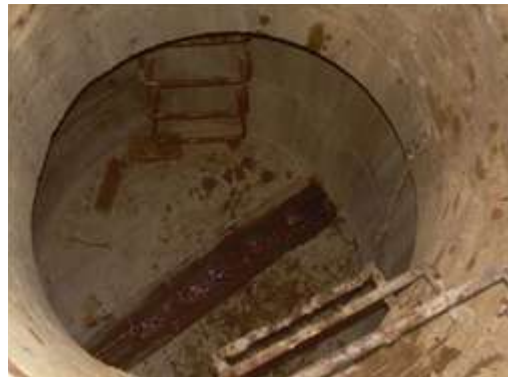
Defect

Adjustment infiltration.

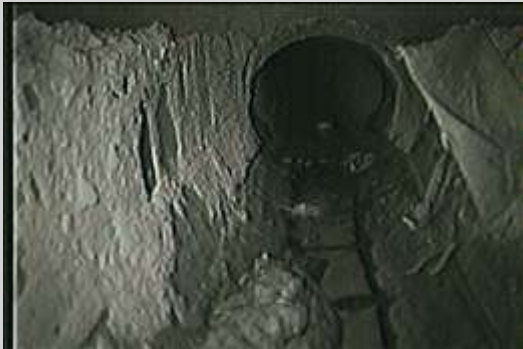
Pipe Out @ 12 O'Clock

Infiltration: **Evidence** Pipe Seal Cond: **Unknown**
